EMERGENCY ACTION PLAN  
FOR  
P.R. MALLORY  
CRAWFORDSVILLE, INDIANA

July 1986

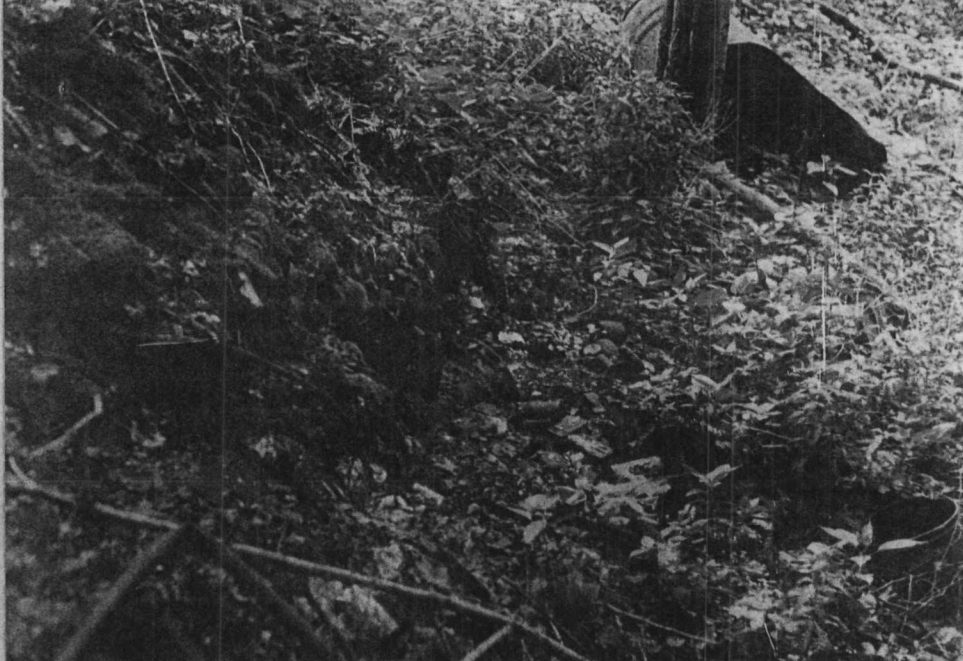
#1  
P.R. Mallory, Crawfordsville,  
Indiana  
Capacitors dumped in ravine  
north of concrete slab  
Photographer: Dean Geers  
5-19-86, 1220-1400 hrs

A backhoe and front-end loader will be utilized to collect the contaminated soil and capacitors and will transport the debris to the Visqueen-lined, concrete slab. The material will then be placed on a size 3 (3 inch) screen to separate the capacitors from the contaminated soil. The segregated capacitors will be placed in 30-gallon fiber drums for incineration. The remaining contaminated soil will be placed into lined, open box, semi-trucks (capacity of 30 cubic yards) for transportation to an approved PCB landfill. After removal of

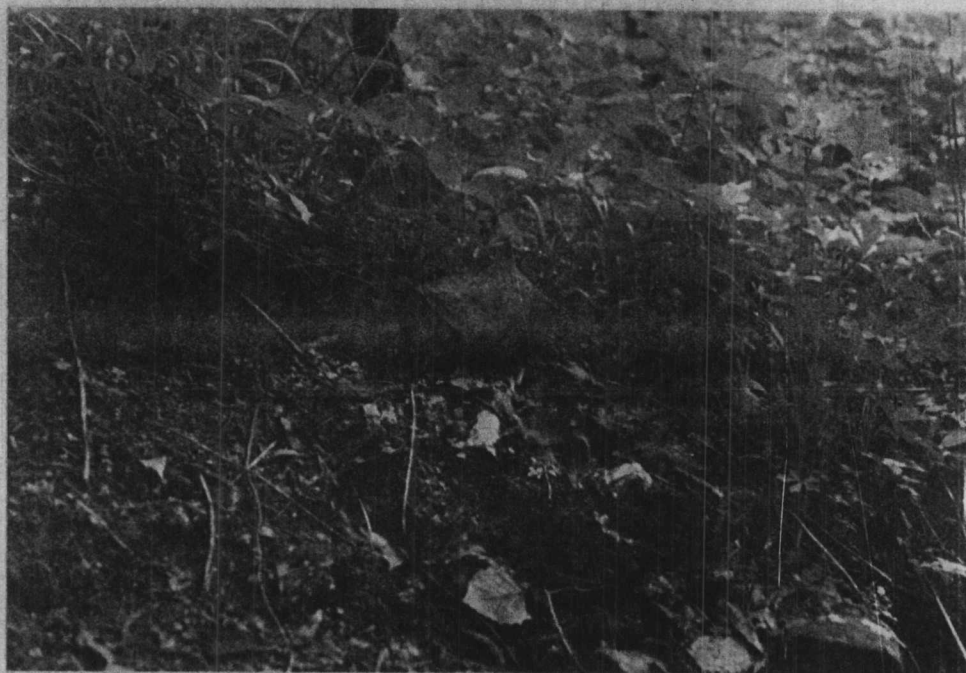
#2  
P.R. Mallory, Crawfordsville,  
Indiana  
Capacitors in ravine  
Photographer: Dean Geers  
5-19-86, 1220-1400 hrs

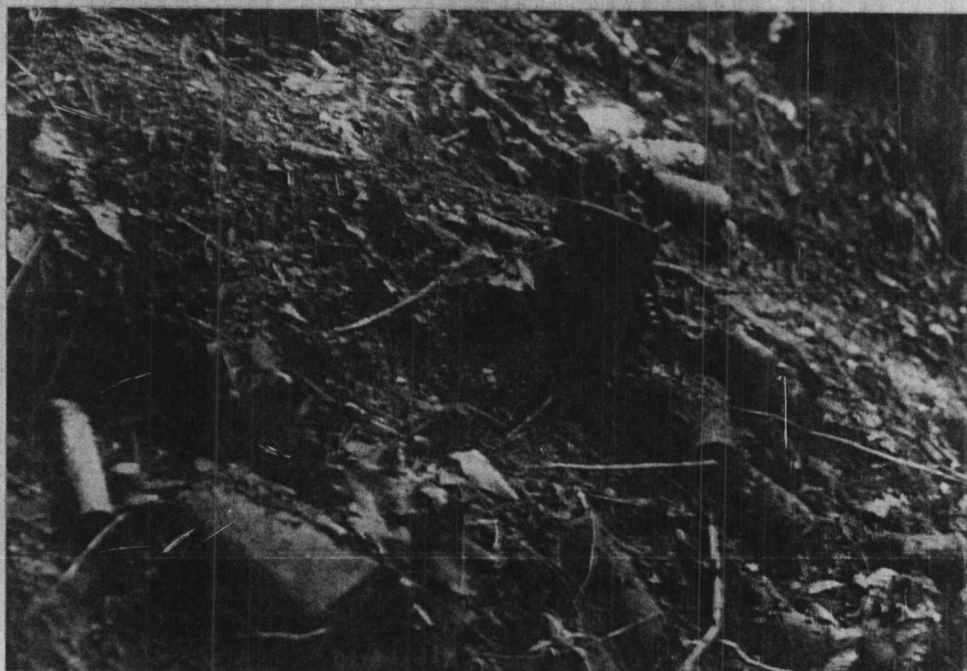
#3  
P.R. Mallory, Crawfordsville,  
Indiana  
Capacitors in ravine  
Photographer: Dean Geers  
5-19-86, 1220-1400 hrs

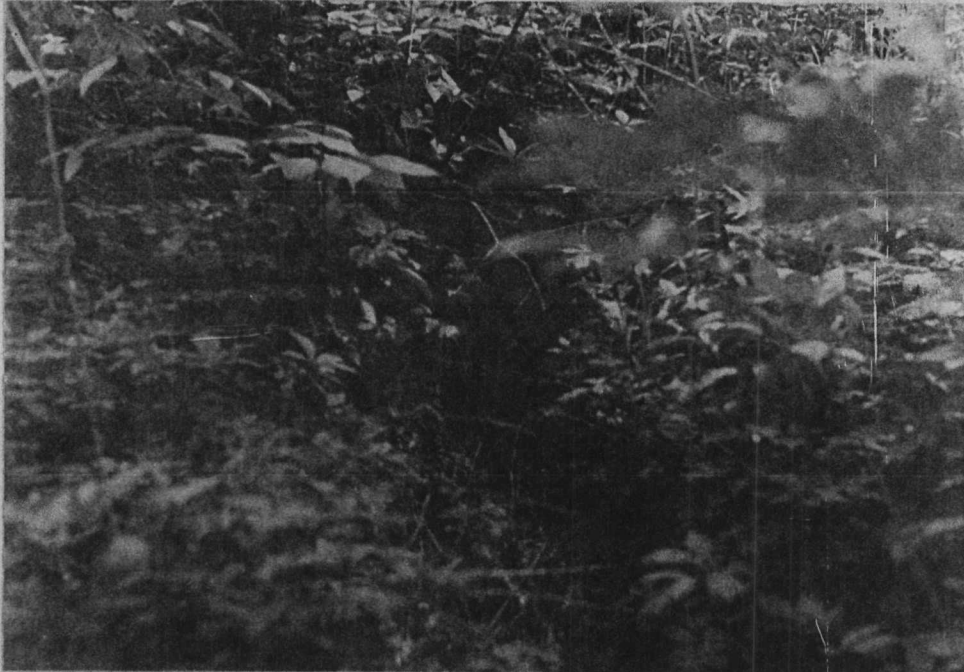
#4  
P.R. Mallory, Crawfordsville,  
Indiana  
Drain tile, believed to be  
from adjacent W.M. Plastics  
facility  
Photographer: Dean Geers  
5-19-86, 1220-1400 hrs

Further to the northeast was the ravine which contained the previously-mentioned intermittent stream. Near the top of the ravine, a drain tile, believed to be from the adjacent W.M. Plastics facility, was observed discharging water along the embankment. A portion of the ravine embankment, approximately 400 square feet in surface area, is composed of discarded capacitors. The TAT estimates that the capacitors may be piled as much as three feet deep near the top of the

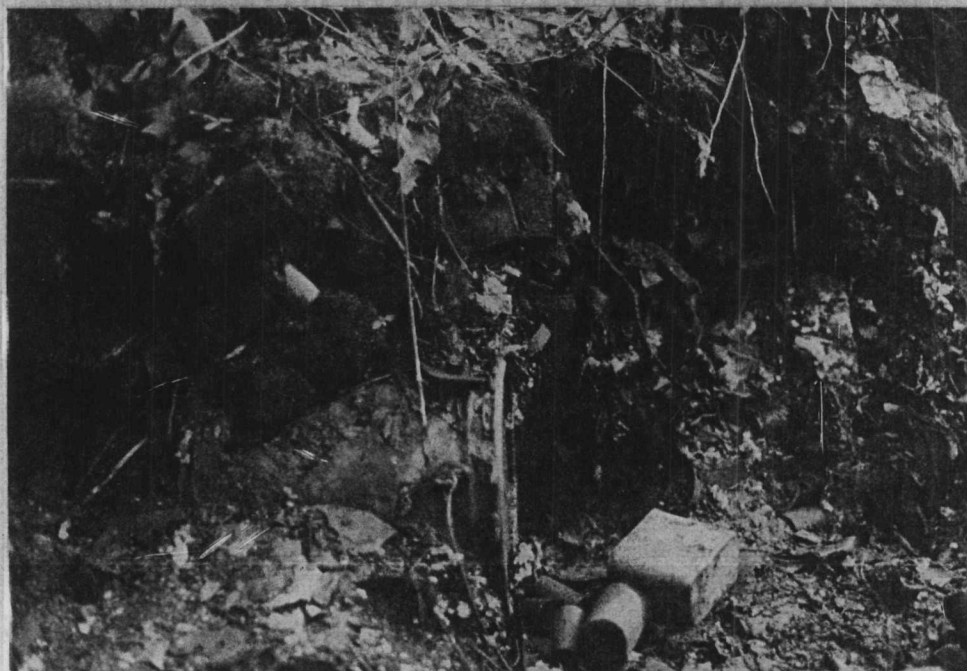
#5  
P.R. Mallory, Crawfordsville,  
Indiana  
Capacitors in ravine  
Photographer: Dean Geers  
5-19-86, 1220-1400 hrs

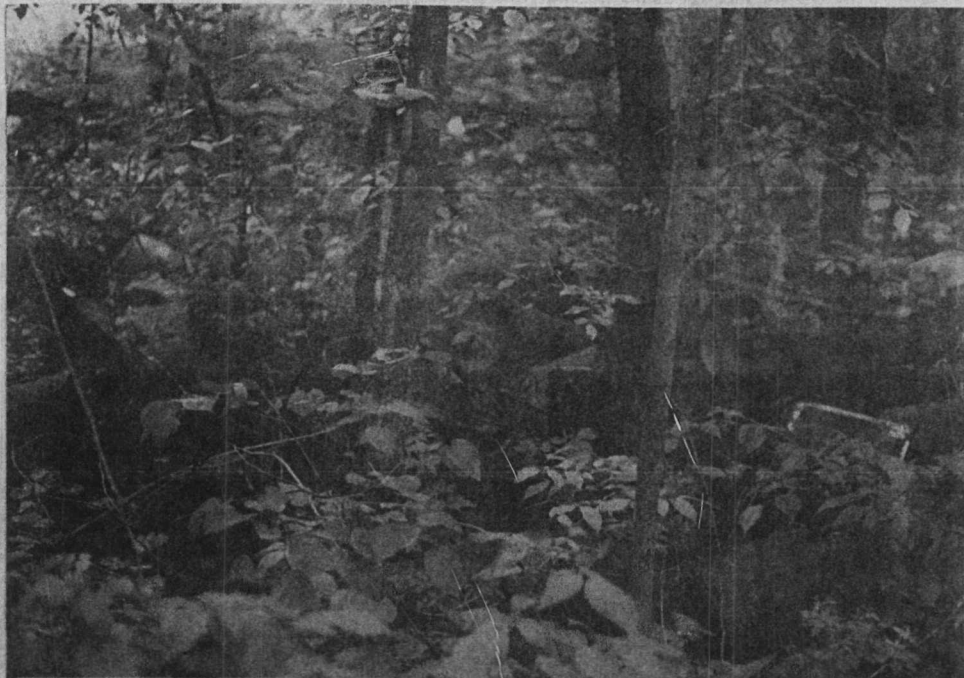
#7

Rusted 5 gal pails near  
ravine

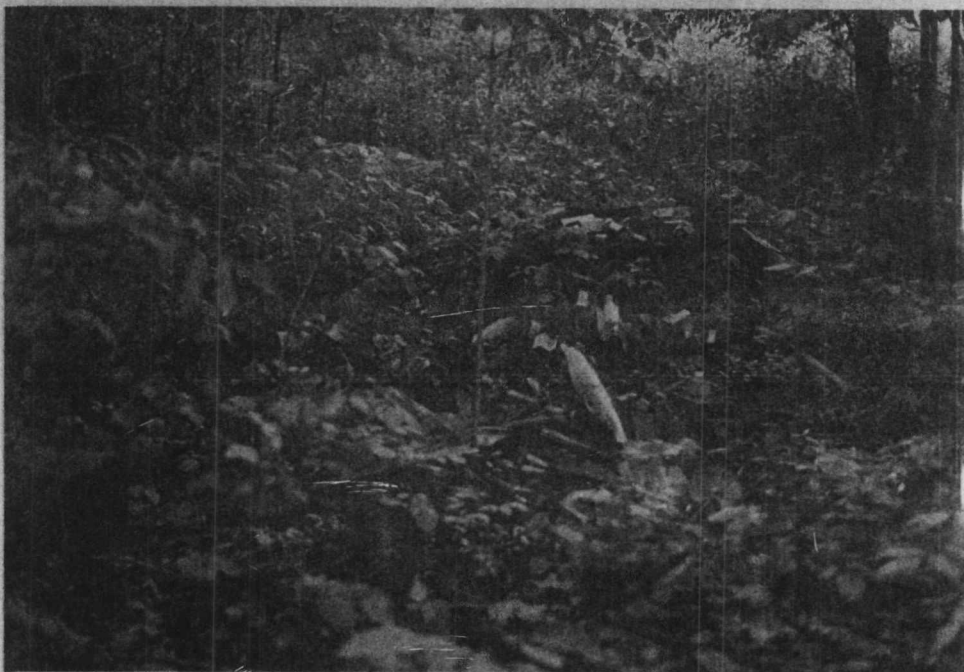
#8

Debris pile near ravine

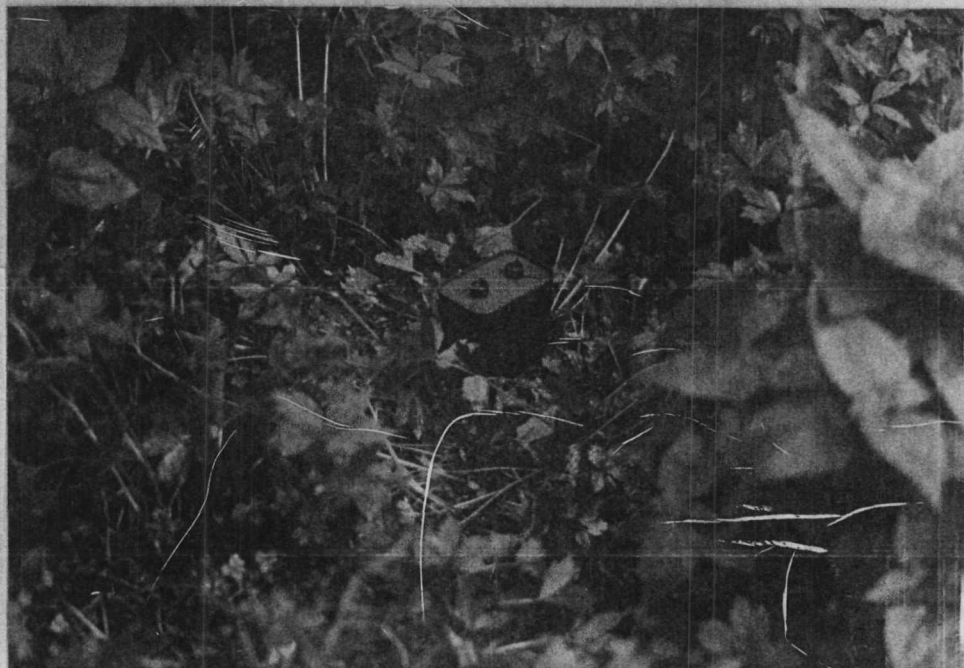
#9

Capacitor near edge of  
ravine

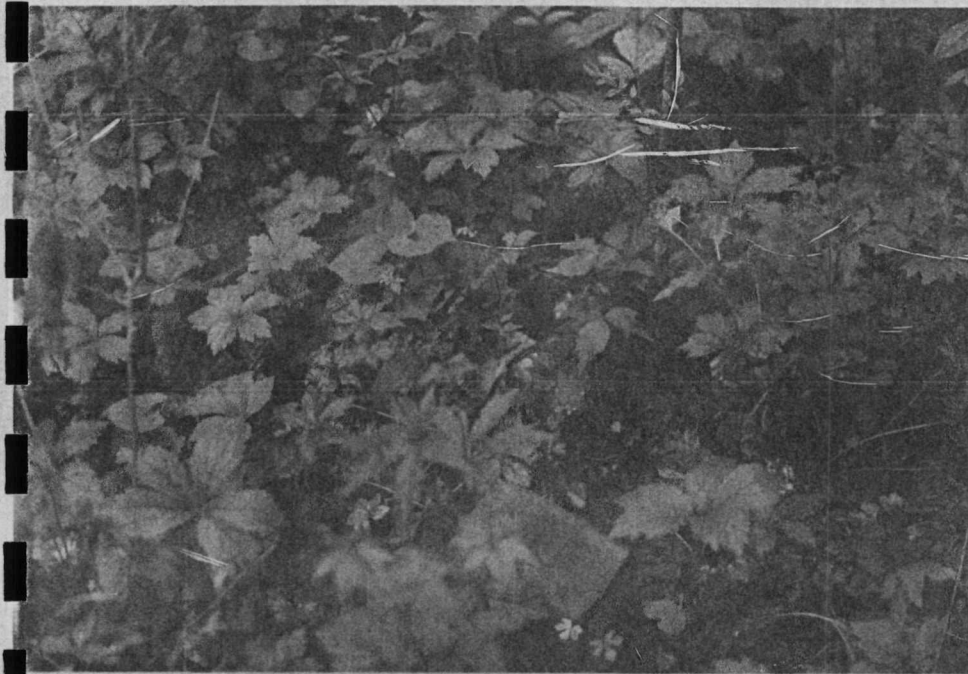
#10  
P.R. Mallory, Crawfordsville,  
Indiana  
Capacitors near edge of  
ravine  
Photographer: Dean Geers  
5-19-86, 1220-1400 hrs

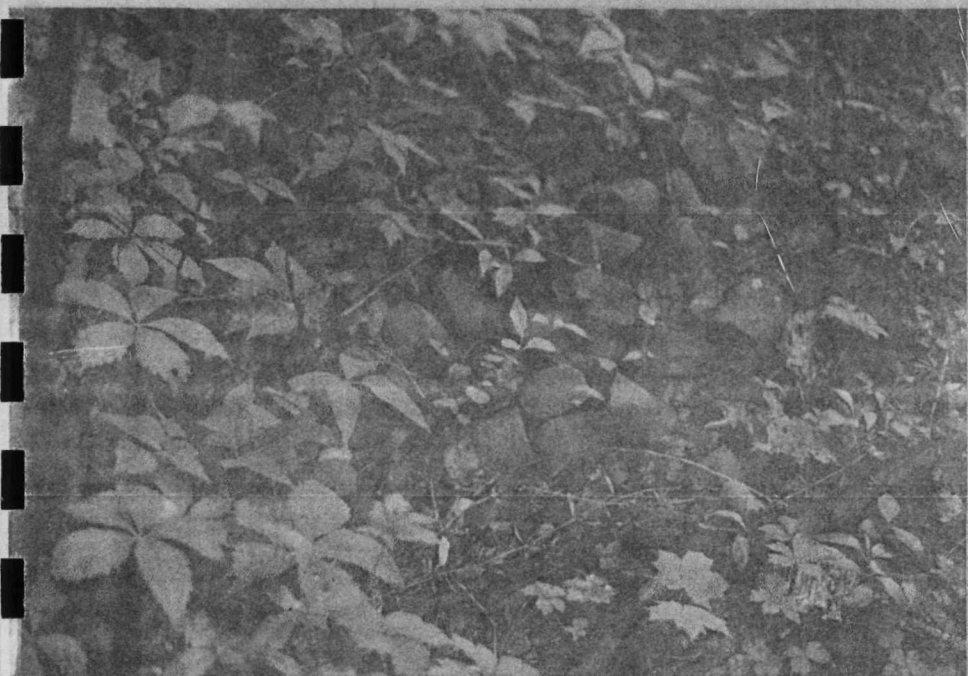
#11  
P.R. Mallory, Crawfordsville,  
Indiana  
Scrap steel in ravine, east  
of capacitors  
Photographer: Dean Geers  
5-19-86, 1220-1400 hrs

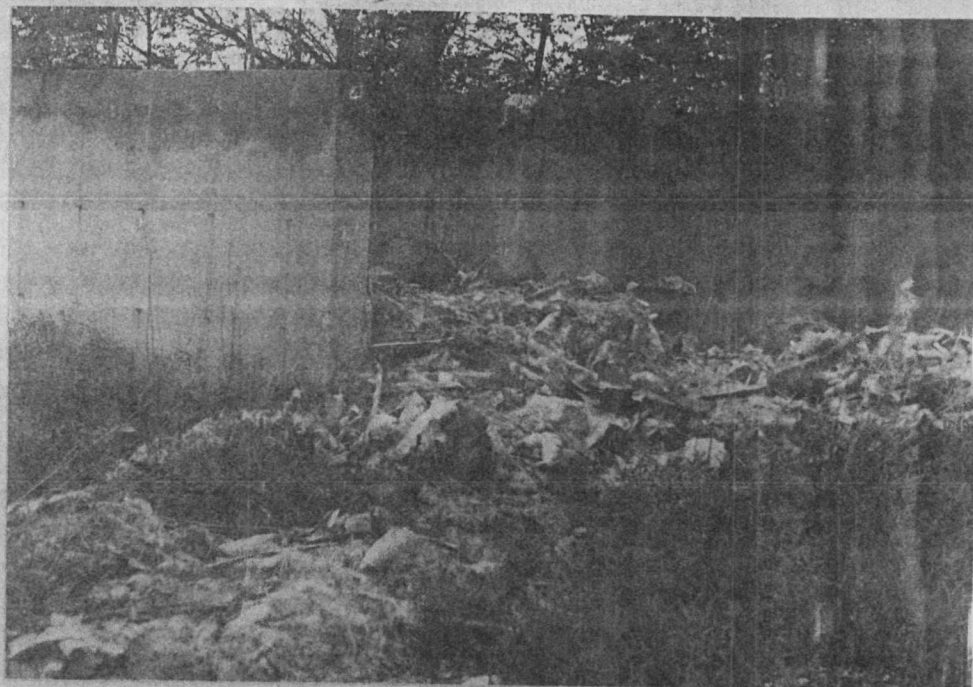
Two small structures lie directly north of the concrete slab (Figure 2). A concrete block pump house contained a pump and holding tank, indicating water was drawn from an on-site well. The poured concrete structure appears to have been an open top incinerator that may have been used by the P.R. Mallory facility. Fiberglass debris was dumped in the remains of the incinerator and the surrounding area.

#13  
P.R. Mallory, Crawfordsville,  
Indiana  
Scrap fiberglass around  
incinerator north of concrete  
slab  
Photographer: Dean Geers  
5-19-86, 1220-1400 hrs

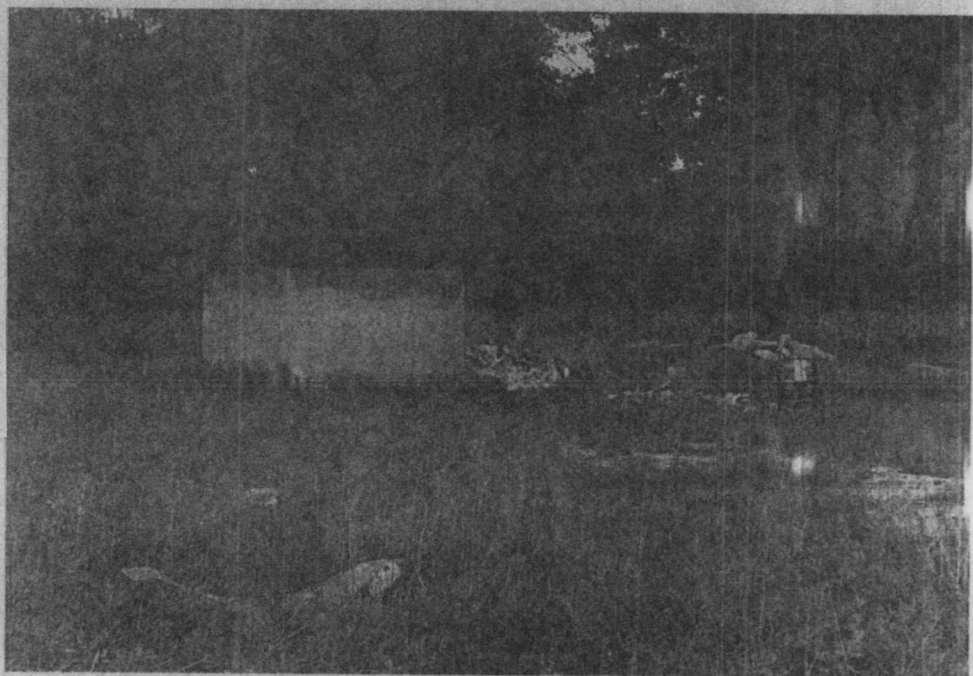
#14  
P.R. Mallory, Crawfordsville,  
Indiana  
Incinerator north of concrete  
slab  
Photographer: Dean Geers  
5-19-86, 1220-1400 hrs

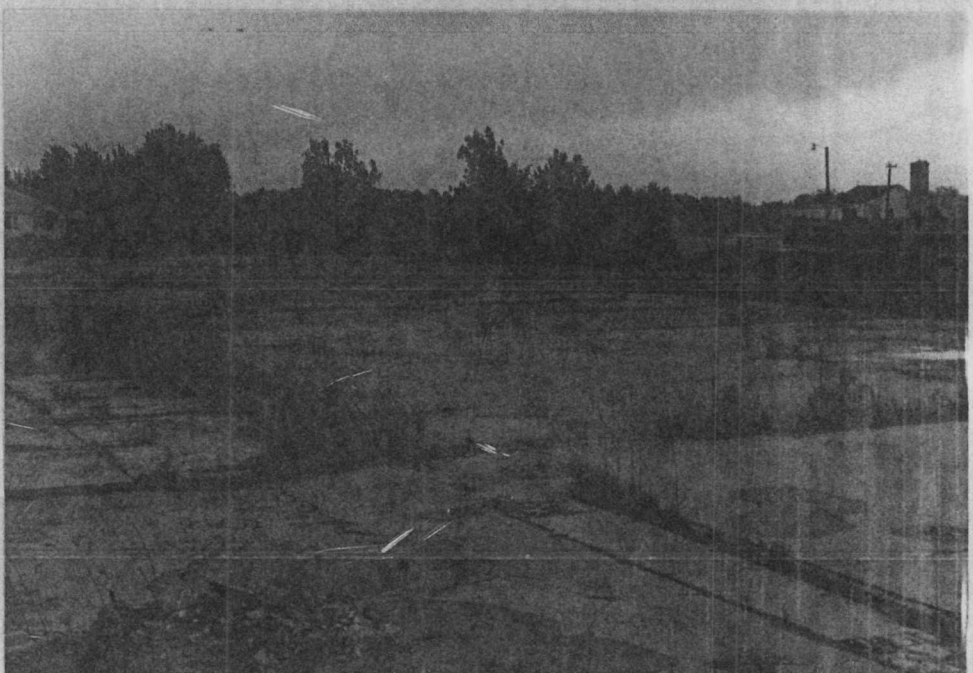
#15  
P.R. Mallory, Crawfordsville,  
Indiana  
Concrete slab where building  
once stood. View looking S-SW  
Photographer: Dean Geers  
5-19-86, 1220-1400 hrs

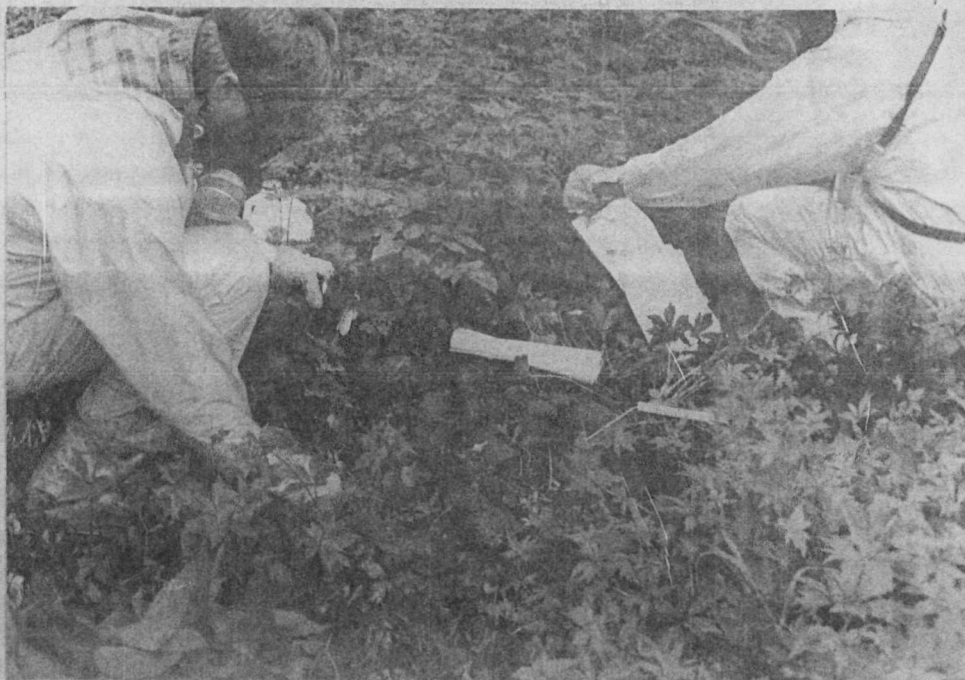
#19

Sampling of soil under pile  
of capacitors near ravine

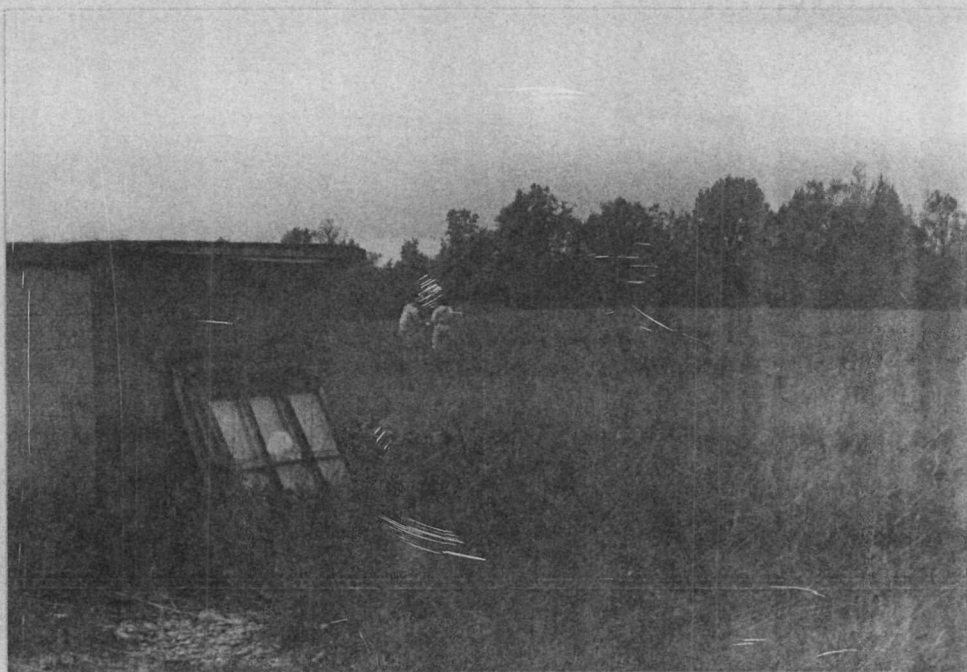
#20

Collection of background soil  
samle in adjacent field.

Pump house in foreground  
Photographer: Dean Geers  
5-19-86, 1220-1400 hrs
